DESIGNATED SUBSTANCE SURVEY REPORT

ISSUED TO: Ready.Set.Reno!
LOCATION: Ready.Set.Reno!
ISSUING OFFICE: AEOC Group Inc
ISSUED ON: December 21st, 2020
CONTACT: Real Landriault (416-985-5025)
PROJECT: Designated Substance Survey Report
AEOC Group Project No. 2020-R2724

AEOC Group Inc, a division of Asbestos Environmental of Canada, was retained by **Ready.Set.Reno!** to conduct a **Designated Substance Survey Report** at the **residential building**.

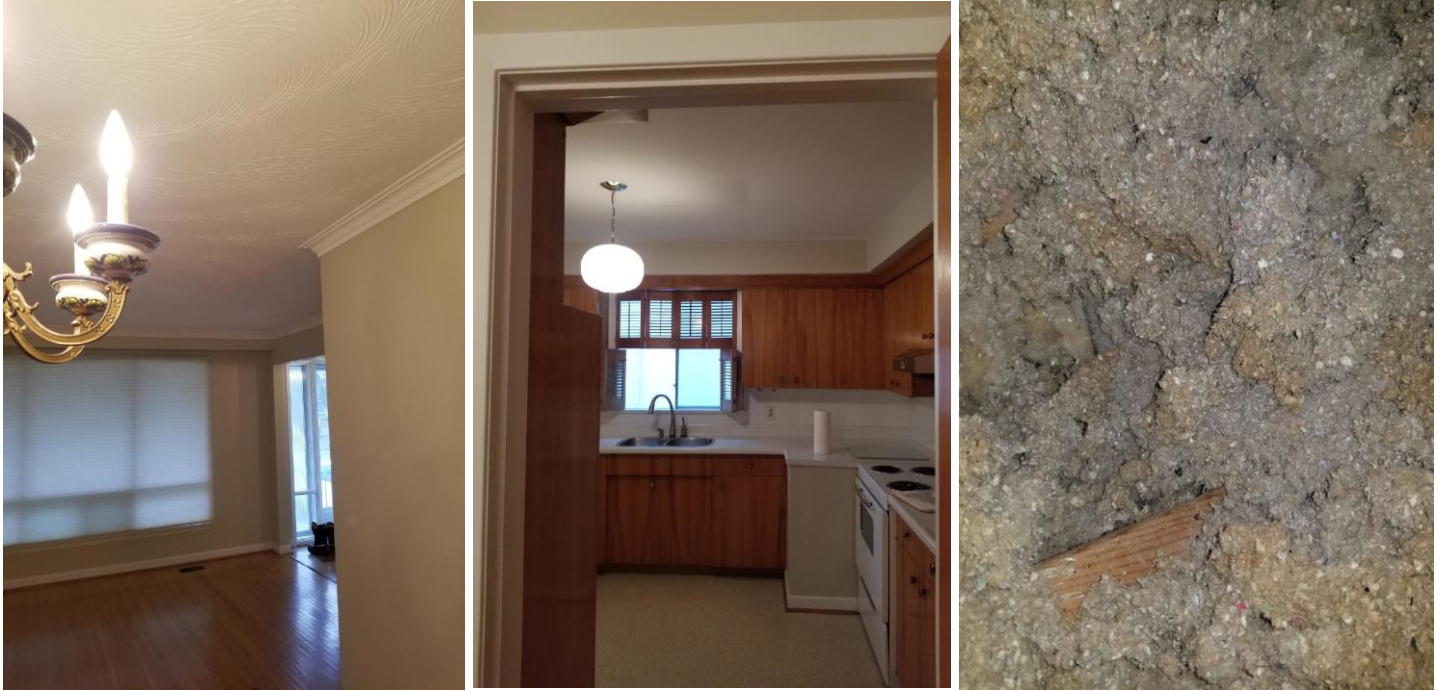
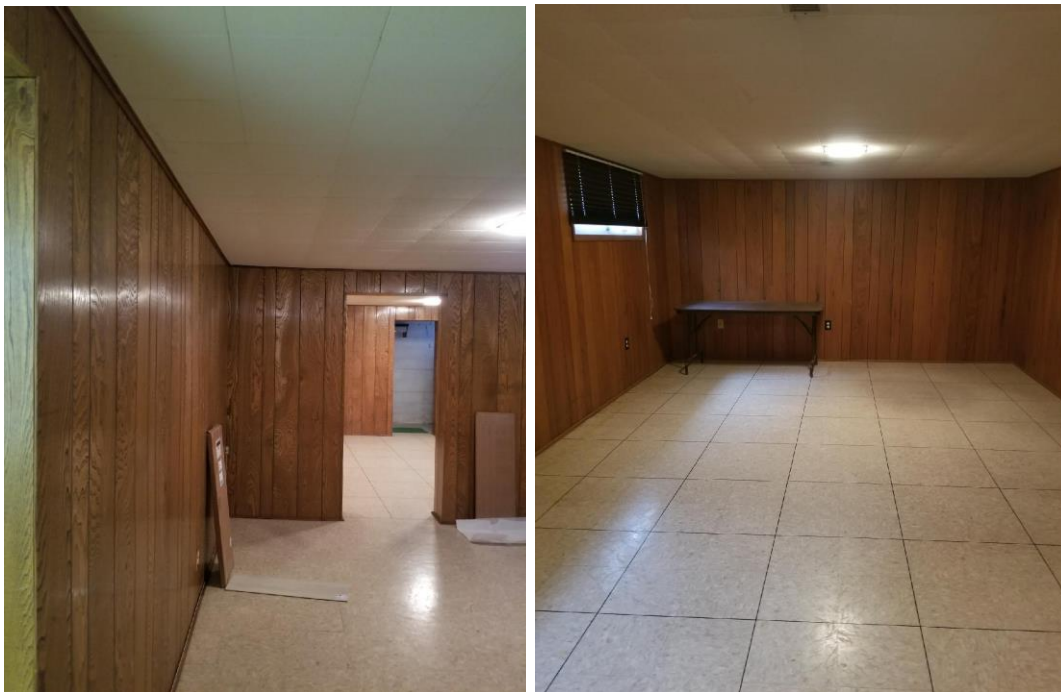
2.9 Photographs

- **Based on laboratory test results, asbestos was found in the samples collected from locations A.**
 - Basement VCT Tiles – White Tiles
 - Register Wrap

Prior to construction all ACM must be repaired or removed in order to comply with current Regulations (Ontario Regulation 278/05) and MOL field of practice. The following materials require repair or removal.

<u>Material</u>	<u>Location</u>	<u>Recommended Procedure</u>
VCT Tile	Basement – White Tile	Type 1 Measures and Procedures.
Register Wrap	Throughout Home	Type 1 Measures and Procedures.
